Operating instructions

Servo drive system SINAMICS S210

SINAMICS S210 converter SIMOTICS S-1FK2 servomotor

Edition 12/2017 www.siemens.com/drives

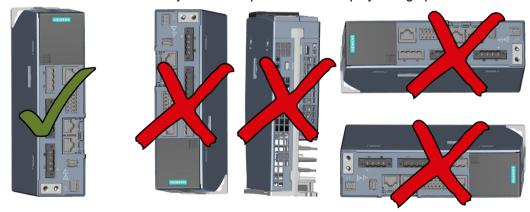
Figure 5-2 Mounting position of the converter

Install the converter vertically with the flap for the LED display facing upwards.

- Maintain the minimum clearances to other components.
- Use the recommended hardware (screws M5) and comply with the specified torques.

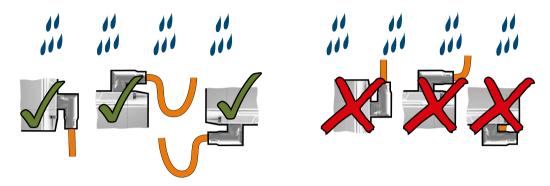
Figure 5-9 Permissible and impermissible cable routing when connecting in a damp environment

If you are operating the motor in environments in which moisture can arise follow the installation instructions below.

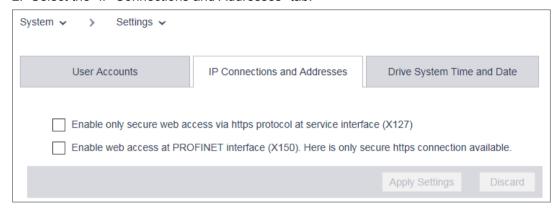
Figure 6-35 IP connections

- 3. Activate the desired connection options.
- 4. Click "Apply Settings" to save the changes in the RAM of the device.
- 5. Click I to save the data permanently.

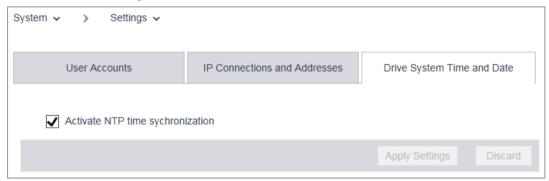
Figure 6-36 System time

- 3. Deactivate/activate "Activate NTP time synchronization".
- 4. Click "Apply Settings" to save the changes in the RAM of the device.
- 5. Click I to save the data permanently.
