OSP-U100M OSP-U10M

ALARM & ERROR LIST (3rd Edition)

Pub. No. 4187-E-R2 (ME37-004-R3) Oct. 2002

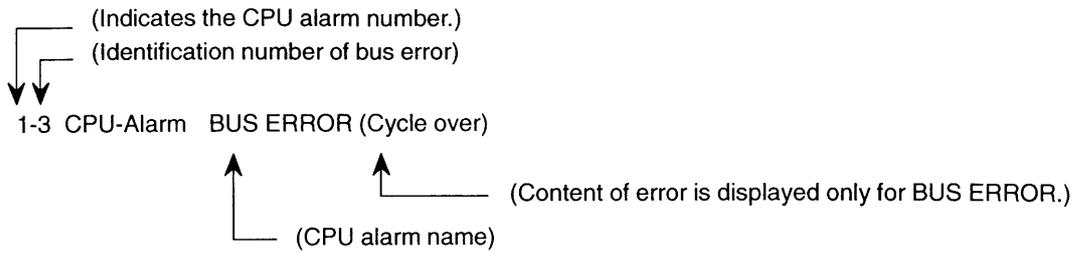
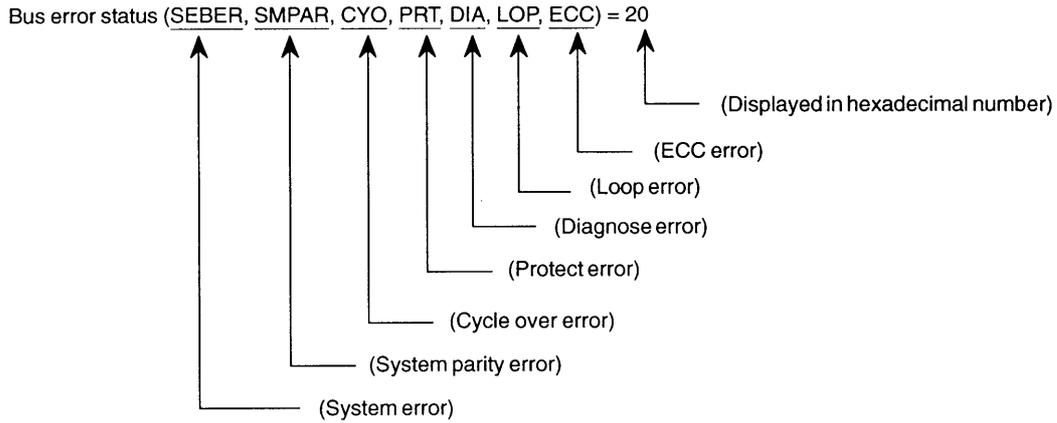
Display Format of CPU Alarms (Bus error)

Special status word = 0165

Access address = 00104250

D0 = 43520000	D1 = 00000000	D2 = 0000000B	D3 = 00000210	(Indicates the data register D0 through D7.)
D4 = 0000000A	D5 = 00000000	D6 = 00000000	D7 = 00000000	
A0 = FFFFCC06	A1 = 00000000	A2 = FFFFF7C7	A3 = 00000000	(Indicates the data register A0 through A7.)
A4 = 00000000	A5 = 00000000	A6 = 00000600	A7 = 0007FC84	
US = 0007FC84	IS = 000FFEE4	MS = 0000CFB0	SR = 0000100D	
PC = 0002E704

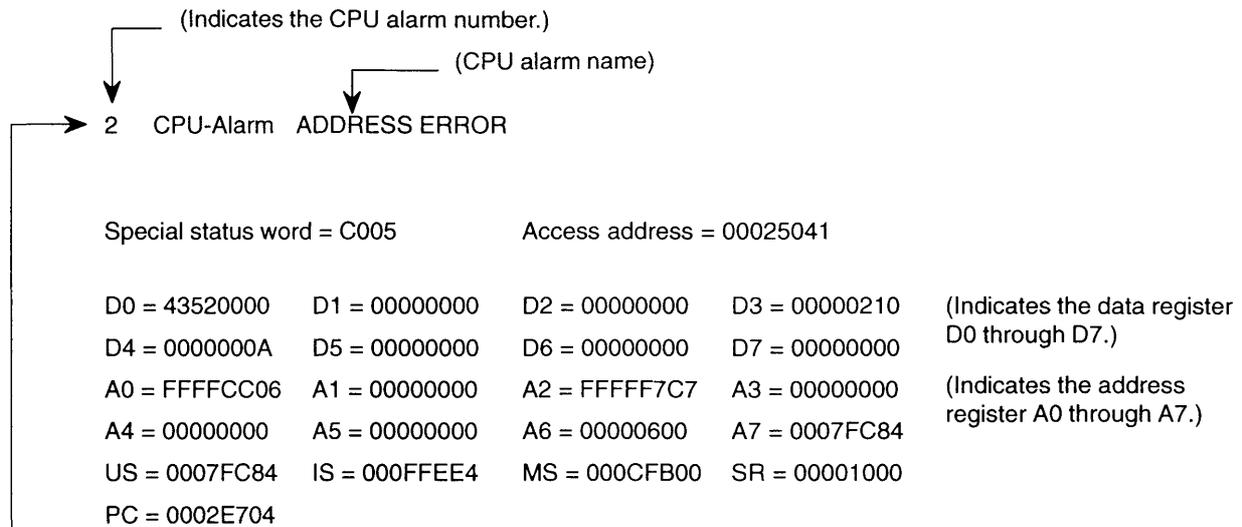
Display Format of CPU Alarms (Address error)

Depending on the alarm content, following display is given.

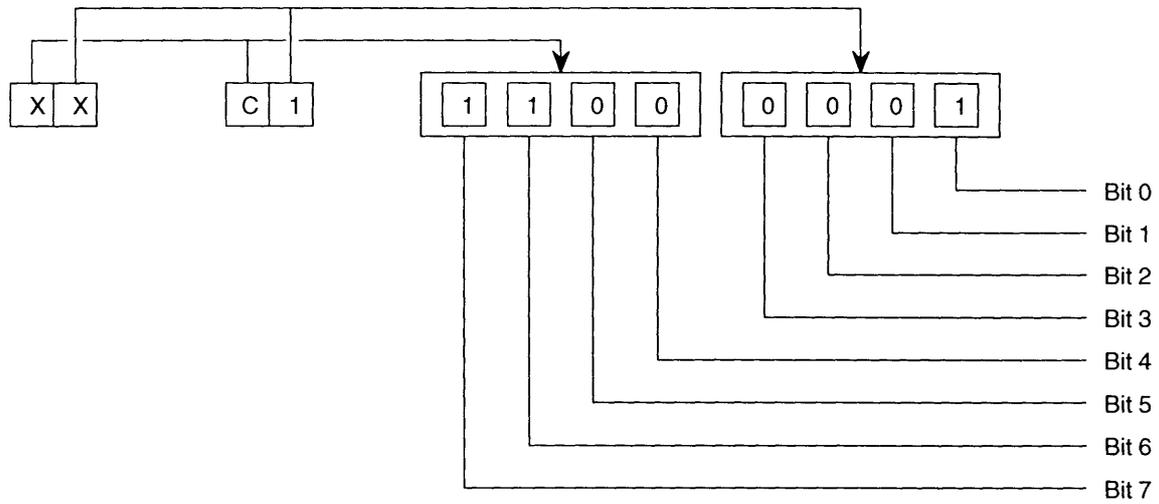
If an alarm occurs, a hexadecimal number is displayed. If "\$C1" is displayed, for example, first convert this "\$C1" into bits.

After the conversion, it is known that Bit0, Bit6, and Bit7 are ON. See the information above and you will find that these error codes correspond to "battery error", "ECP INT signal", and "ECP RUN signal", respectively.

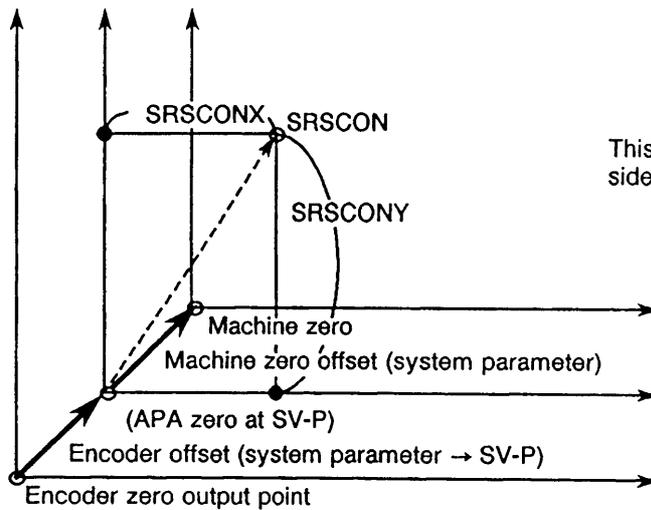
★ 1243 CON 0 pass

The SRSCON (final command value) value becomes negative..

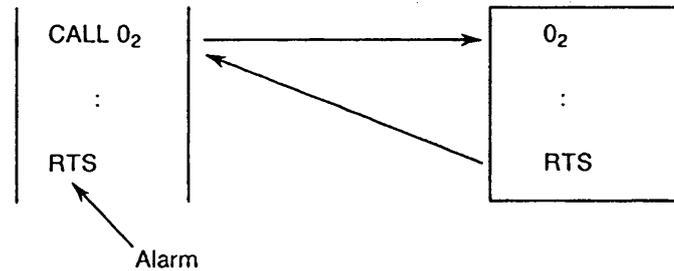
The number of CALL, RTS, MODIN, and MODOUT statements in a part program
Program Example:

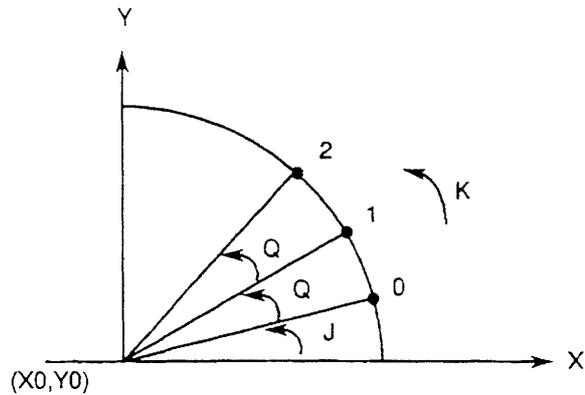
None->Q specified preceding K

- 1-> More than 10 sets of Q commands specified
- 2-> The K command value is outside the specified range ($1 < K < 65535$).
- 3-> K commands are specified in succession.

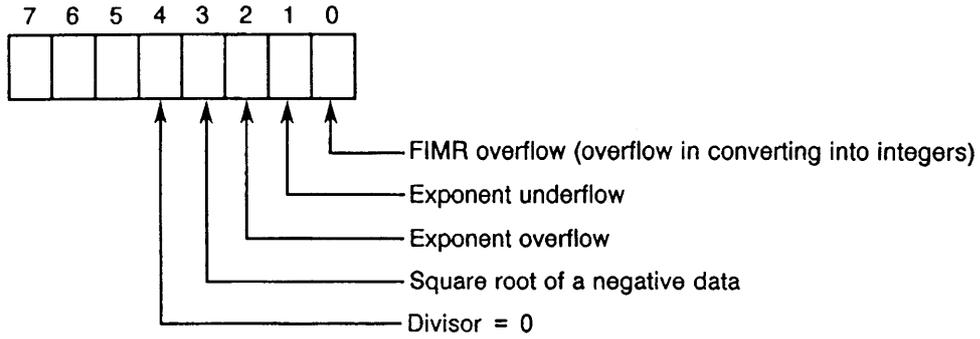
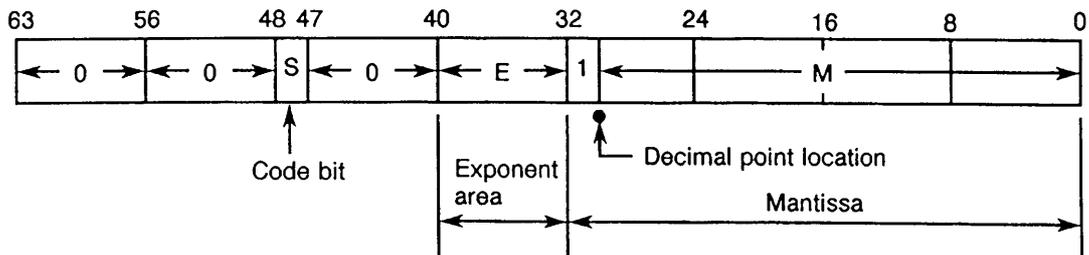
$$0 \leq E \leq 255$$

Value 128 is taken as the standard.
E < 0 Exponent underflow
E > 256 . . . Exponent overflow

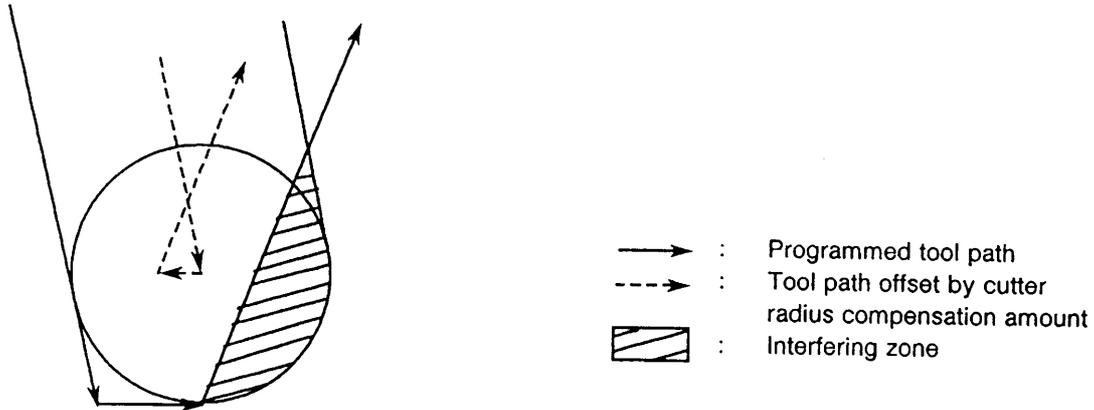
★ 2304 **Cutter radius comp.: interference**

An interference occurs between the cutting width, added to the cutter radius compensation data, and the area which should not be cut. (The angle between the programmed cutter movement direction and the direction of movement created after the compensation is between 90-deg and 270-deg.)

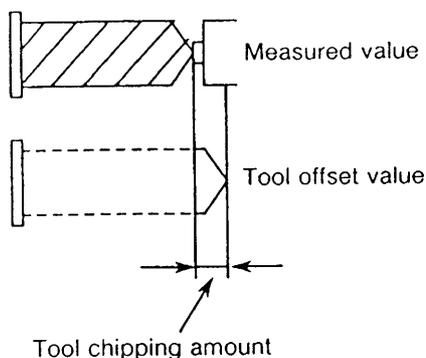
This alarm occurs during the execution of the automatic tool breakage detection cycle (MSB) if any of the following are detected:

- a) The cutting tool fails to contact the touch sensor.
- b) The difference between the tool offset value and the measured value exceeds the allowable limit.

The tool broken alarm occurs if:

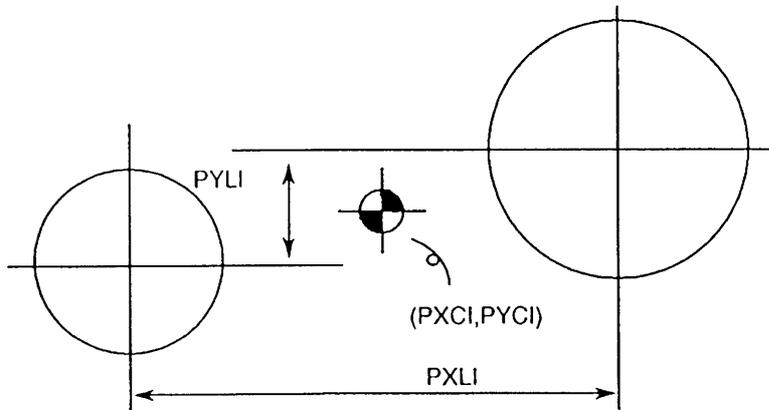
★ 2312 **UNTENDED: center distance error over**

In the automatic gauging subprogram (MSB), differences between the assumed values and the calculation results of the two center points and the distance between them exceed the allowable limit.

An alarm occurs if;

$$| P^*CI - P^*CM | > P^*CE$$

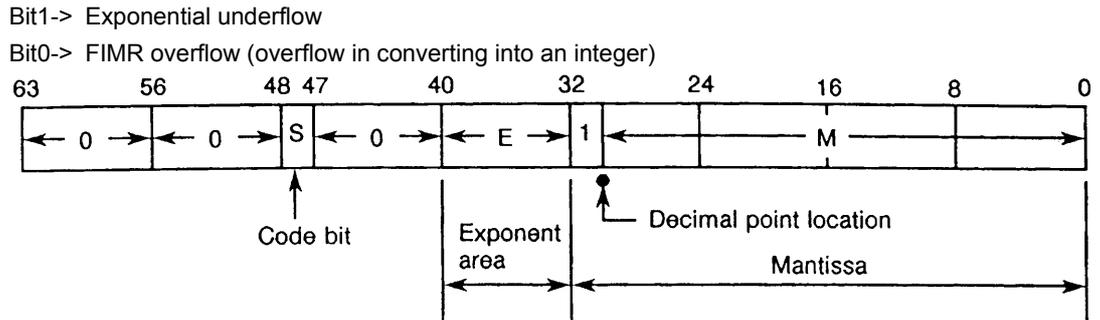
$$0 \leq E \leq 255$$

↑ 128 as the reference

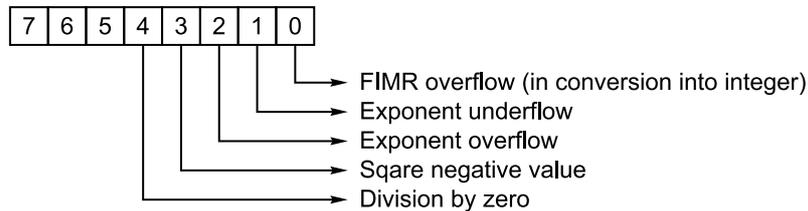
- X-> Place where the operation error has occurred.
- 2-> An error occurred in operation for determining the parallel translation amount of oblique coordinates.
- 5-> An error occurred in operation for determining the matrix of oblique coordinates.
- YY-> Operation error status
